## HIGHWAY ACCIDENT REPORT

PROPANE TRUCK COLLISION WITH  
BRIDGE COLUMN AND FIRE  
WHITE PLAINS, NEW YORK  
JULY 27, 1994

**Adopted: November 14, 1995  
Notation 6479A**

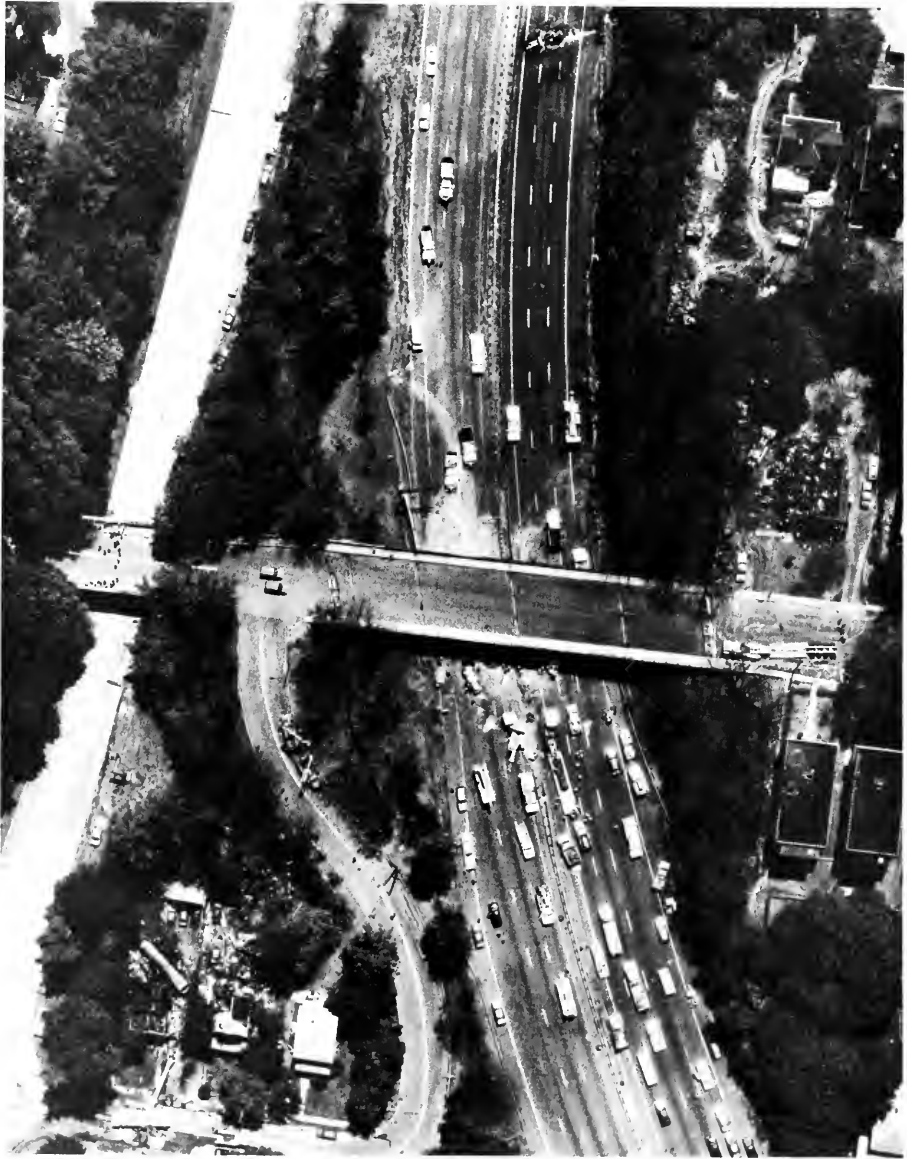
Figure 2. -- Aerial view of accident site (Photo by Chas. H. Sells, Inc.)

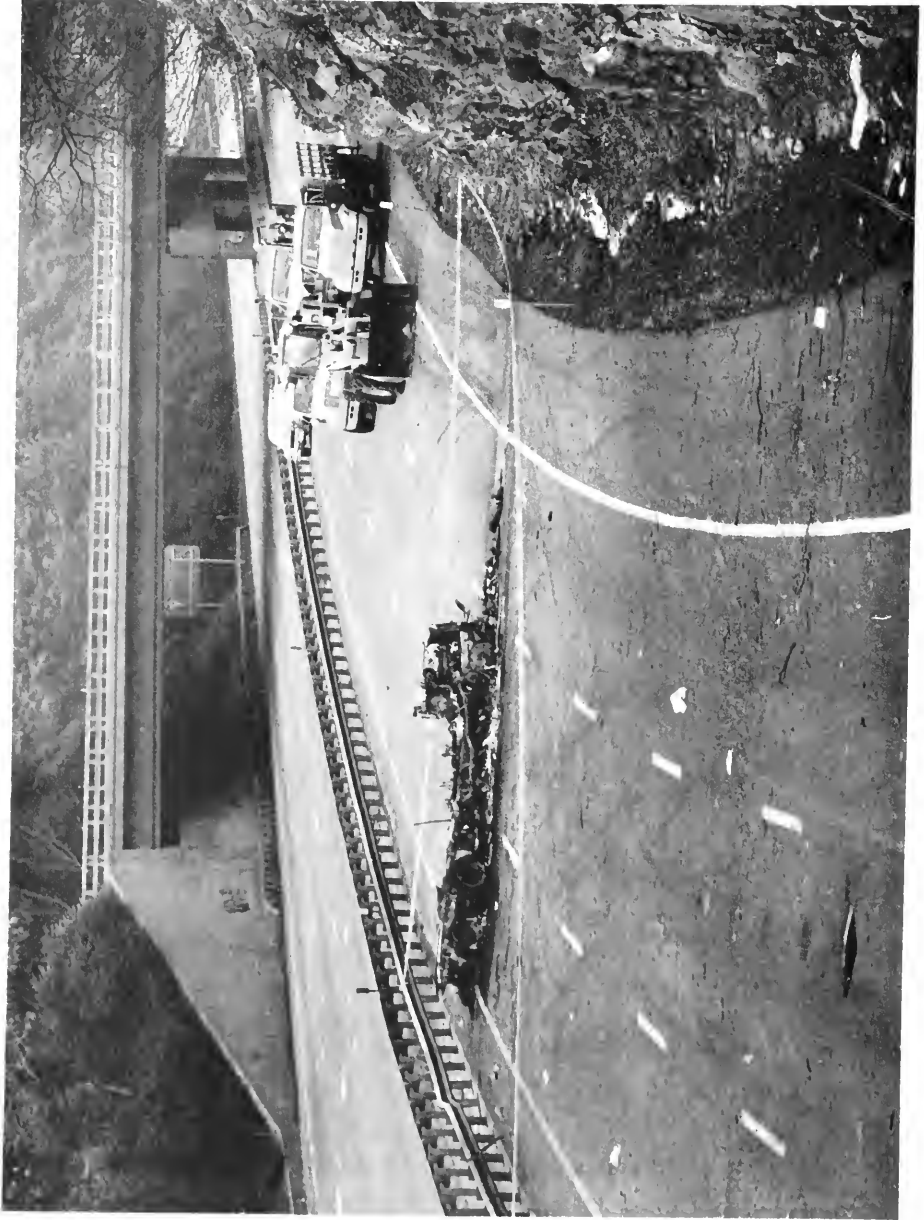
**Vehicle Damage** -- The tractor body and tires were destroyed by fire. The tractor above the frame rail burned, except for the engine, radiator, fire wall, and fifth wheel. Of the remaining components, only the left side of the front bumper was deformed in a way that could have resulted from a collision. The radiator showed no signs of having been in a collision. (See figures 3 and 4.)

Figure 3. -- Final rest position of tractor on I-287 (Photo by Mike Horn)

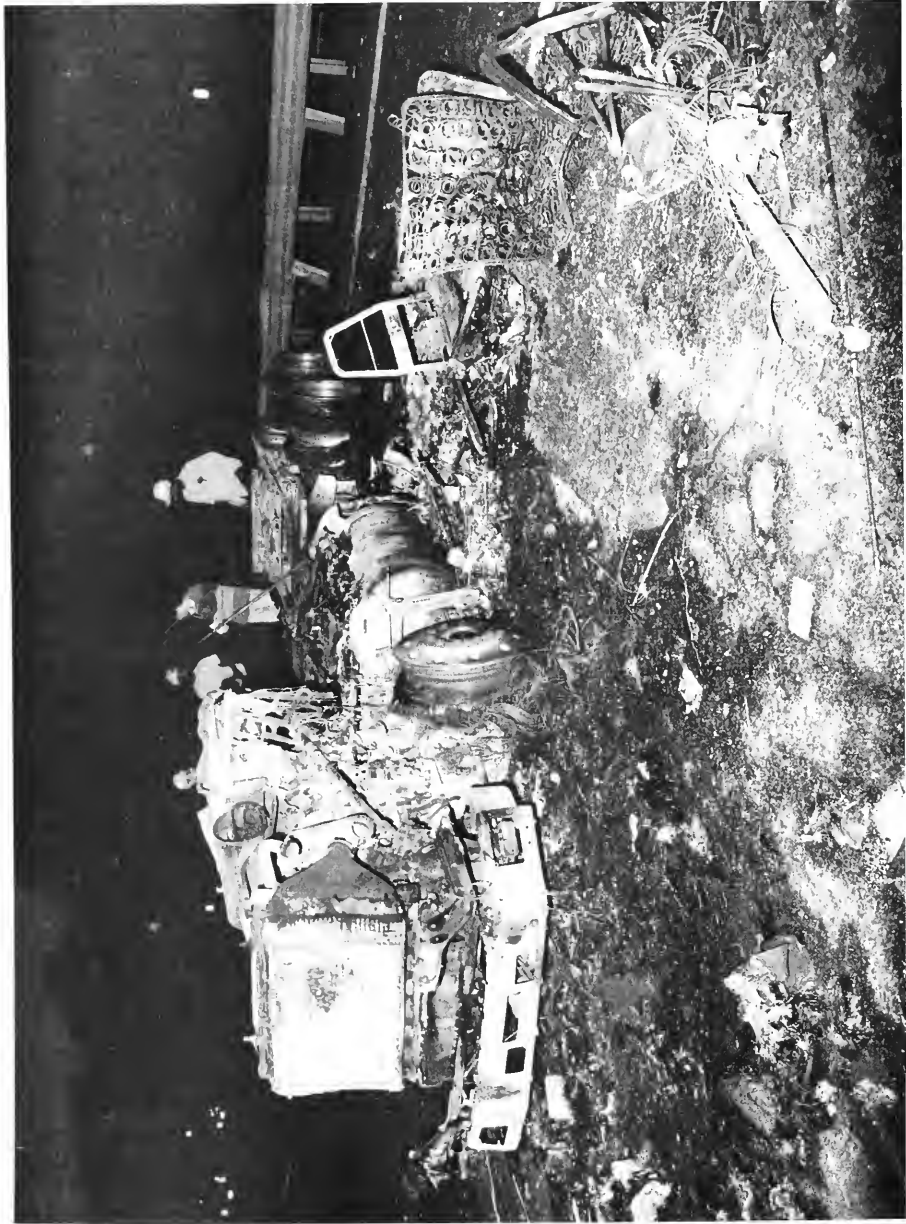
Figure 4. -- Close-up of front of tractor (Photo by Mike Horn)

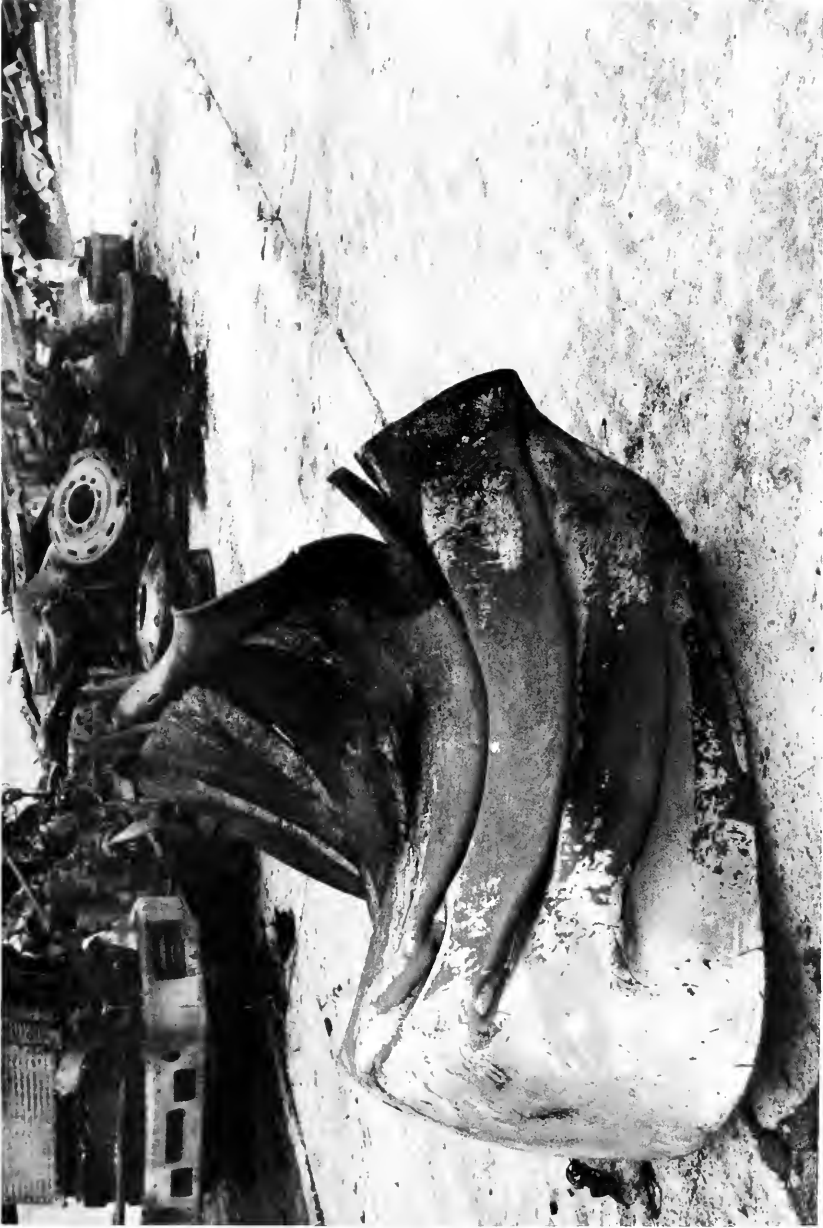
The exterior of the tank was scorched, except for an area at the lower rear and for the rear manhole cover. A portion of the head was found separated from the tank. The head contained a large cylindrical indentation that was oriented in a horizontal direction (consistent with impact at a 90-degree angle during a vehicle rollover). (See figure 5.) The size of the indentation was consistent with the diameter of the vertical columns of the Grant Avenue overpass. The landing gear, the two-axle assemblies, and the underbody plumbing of the semitrailer were torn away.

Figure 5. -- Front head of cargo tank

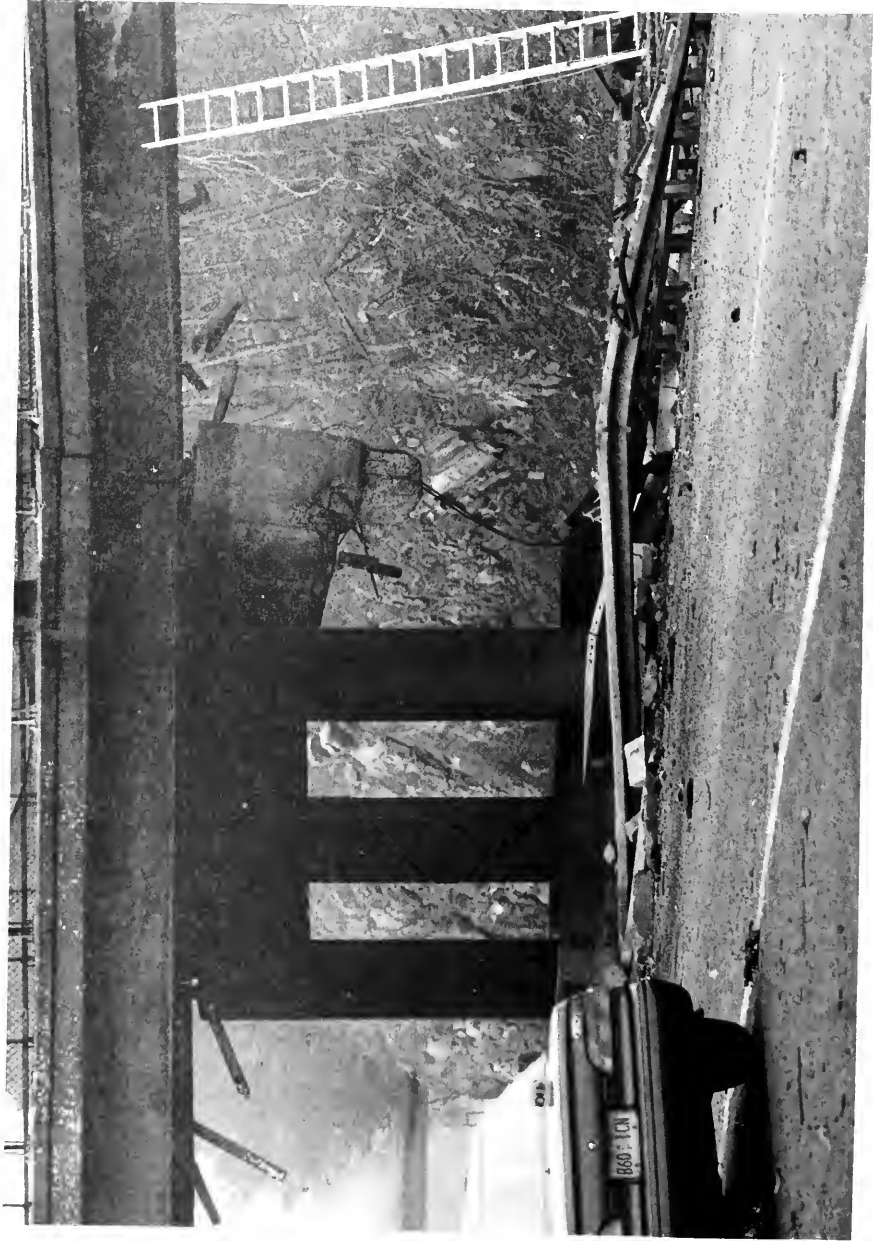
**Highway and Bridge Damage** -- Both the eastbound and westbound median guardrail on the eastbound approach to the bridge was destroyed. The pavement was scorched in several places. The west bridge column was sheared off at the point of impact, causing that portion of the pier cap beam and stringers to sag. (See figure 6.) After the accident, the superstructure was temporarily supported with six steel columns that could take the load should the cap beam sag further. The two interior spans of the southbound spans were later removed. As of November 14, 1995, the bridge was open to a single lane of traffic on Grant Avenue. The cost of cleaning up and temporarily repairing the bridge was \$254,000, and the New York State Department of Transportation (NYSDOT) estimated that it would cost \$213,000 to repair the bridge and median barrier permanently.

Figure 6. -- Damaged column of Grant Avenue overpass (Photo by Mike Horn)

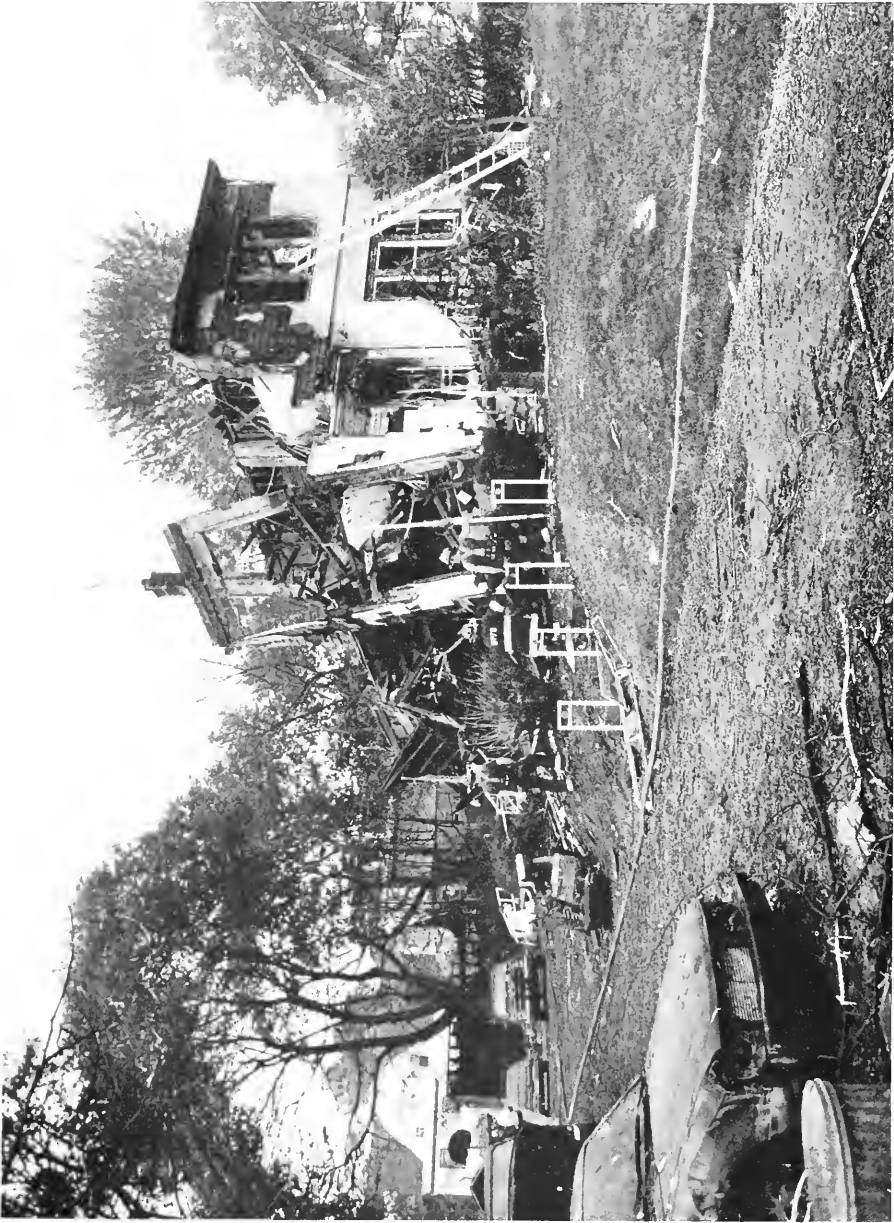
Figure 7. -- Fire damage at 77-81 Grant Avenue (Photo by Mike Horn)

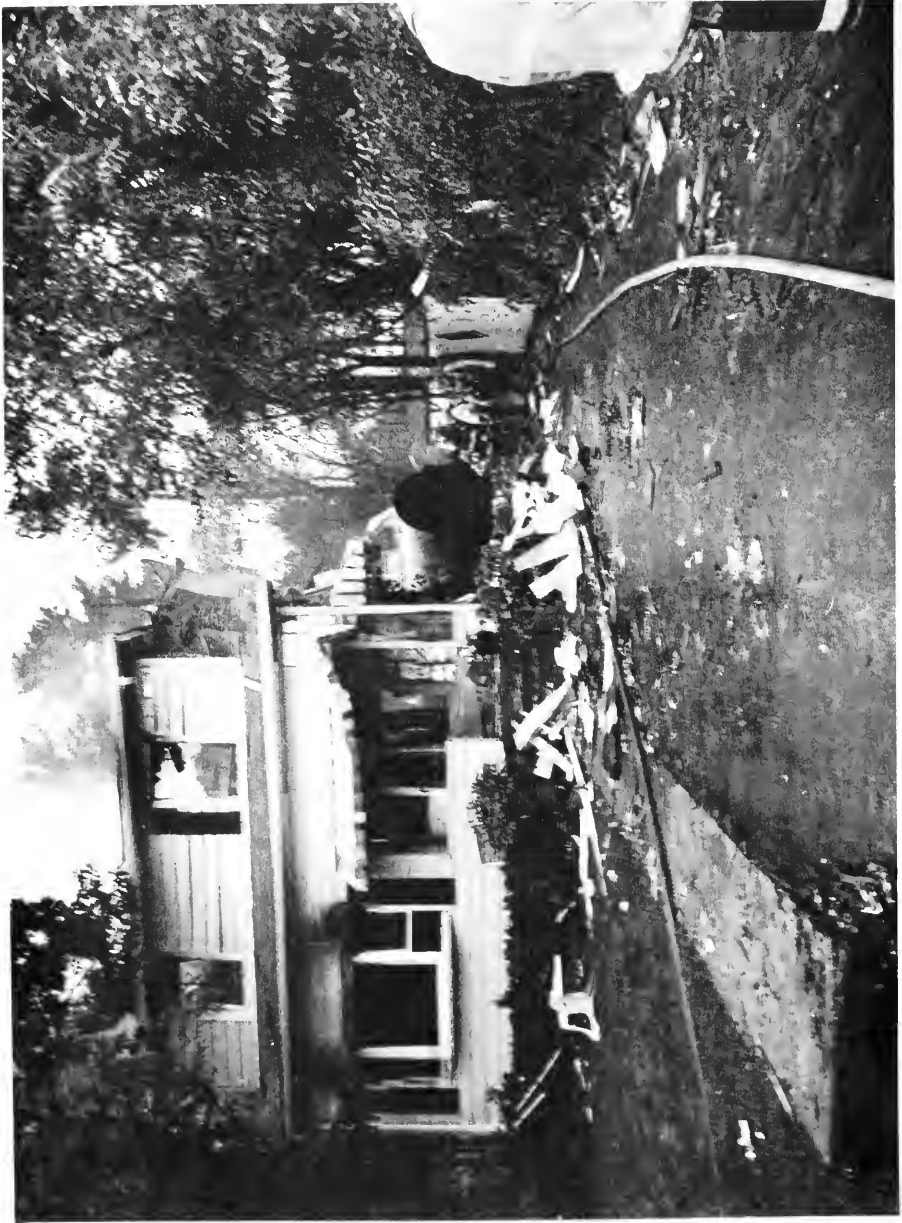
Figure 8. --- Fire damage of 103 Clinton Street (Photo by Mike Horn)

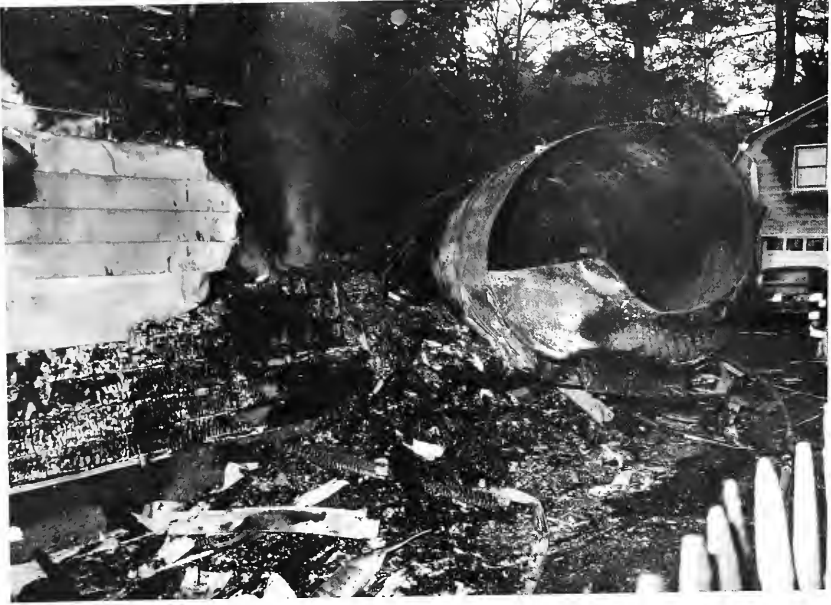
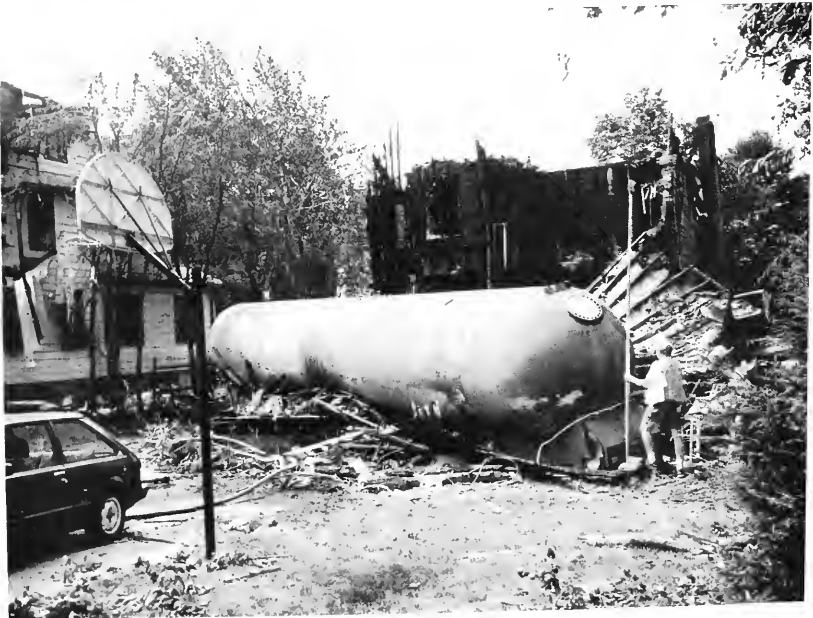
**Tank** -- The amount of crush in the front head was about 21 inches. The separation was between the 9 and 2 o'clock position, looking aft (where the 12 o'clock position is defined as the top of the cylinder) along the heat-affected zone of the weld. The fracture then left the circumferential path and extended forward in the cylinder head and returned to the 9 o'clock position. (See figure 9.)

Figure 9. – Front and rear views of tank at rest at 103 Clinton Street  
(top photo by Mike Horn; bottom photo by Chas. H. Sells, Inc.)

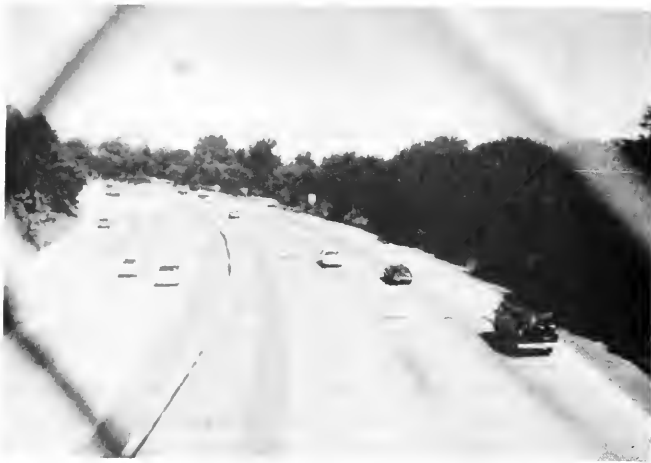
A -- Looking west from Grant Avenue overpass at box beam guardrail

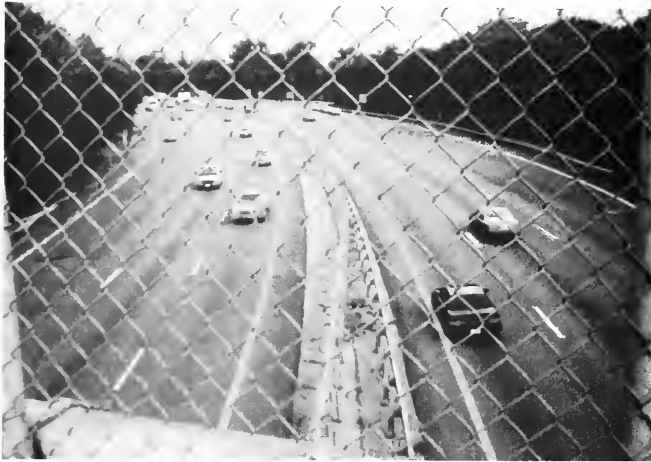
B -- Looking west from Grant Avenue overpass at strong post block-out guardrail

The blocked-out W-beam (strong post) barrier system in place at the time of the accident was a standard design that had been used by the NYSDOT since 1979. After the accident, the guardrail was replaced with another guardrail of the same design. This system is the most common barrier system in use today, but it was designed primarily to protect passenger cars by redirecting them from roadside obstacles. It is classified as an operational semi-rigid system by the AASHTO *Roadside Design Guide*, which means that it has demonstrated satisfactory field performance in terms of construction and has been successfully crash tested for automobiles.<sup>34</sup> In crash tests, this barrier was marginally successful in redirecting two pickup trucks weighing 3,260 and 4,179 pounds, respectively.

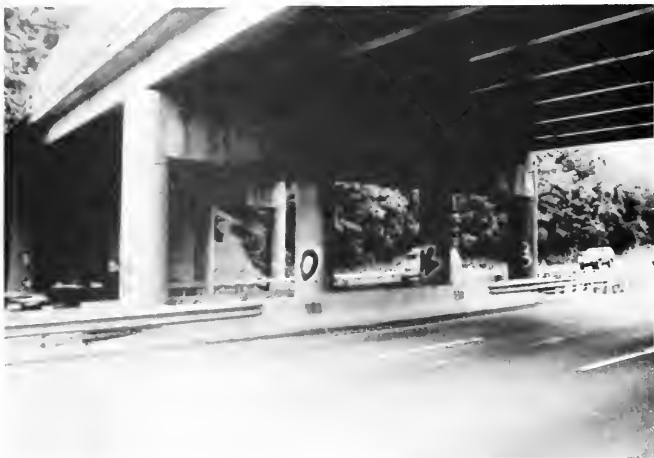
C -- Attachment of W-beam guardrail to concrete barrier
